## **Flow-Control Systems Proof of Concept for Snowmelt Runoff at McMurdo Station, Antarctica**

Final Report

Under   Engineering for Polar Operations, Logistics, and Research (EPOLAR)  
EP-ANT-15-04, "Drainage Solutions Implementation"

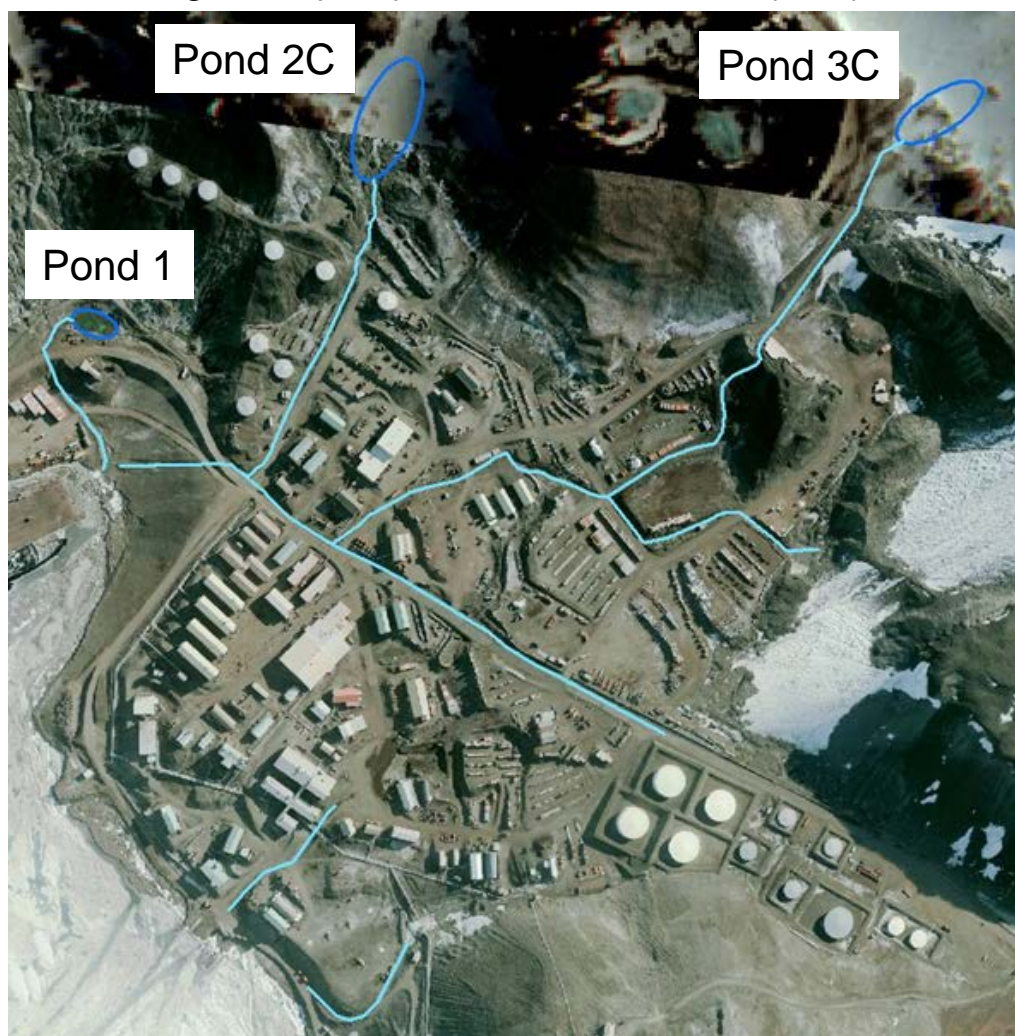
Figure 3. Proposed pond locations from Affleck et al. (2014c).

Ponds detain flow, attenuating the peak and allowing sediment to settle (Ferris 1983). The sediment ponds designed for McMurdo Station were located upstream of drainage paths to capture the snowmelt runoff from subbasins and to control the flow in the channels (Figure 3) (Affleck et al. 2014c). A typical pond would require a riser and outlet pipe; however, the use of a riser and a piped outlet in McMurdo conditions is infeasible due to maintenance requirements from ice accumulation. The design metrics for McMurdo were fully described in Affleck et al (2014c). The sediment ponds were designed to accommodate both water and ice accumulation with the notion that these ponds should be maintained on a regular basis to remove ice and sediment.

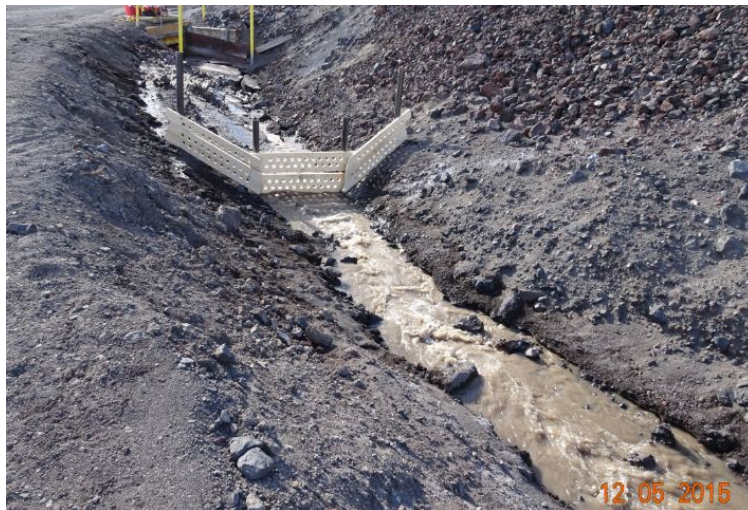
Figure 8. Prototype anchored wooden weir tested along the main channel.

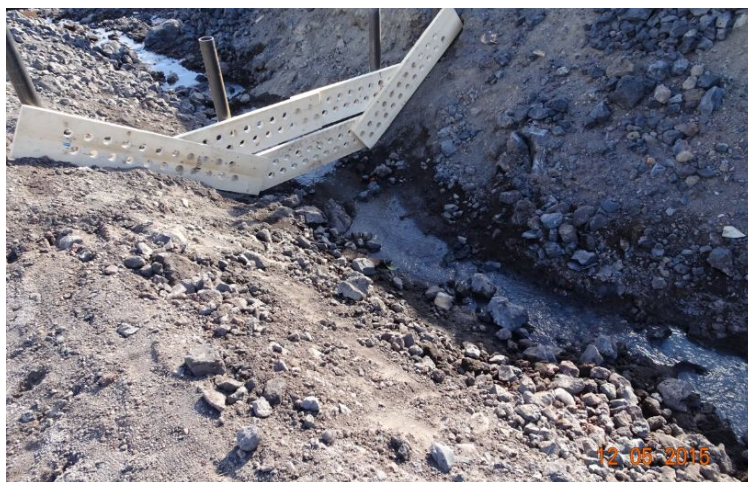
Figure 9. Prototype anchored wooden weir tested along the channel on Gasoline Alley.

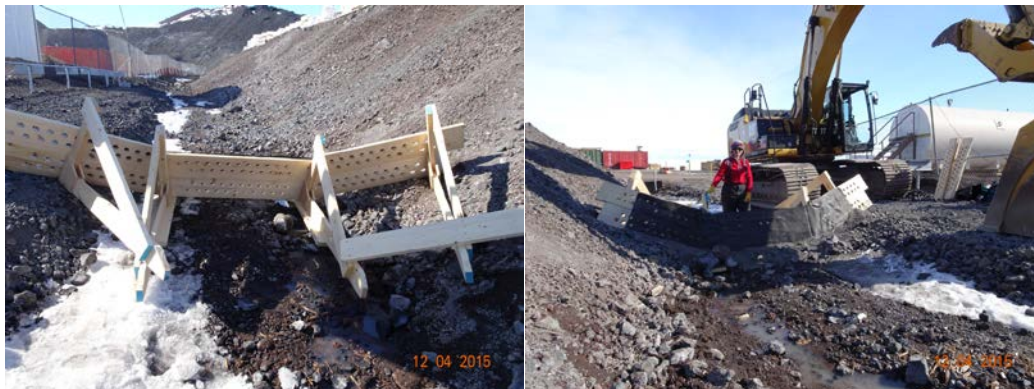
Figure 10. Prototype unanchored wooden weir tested along one of the channels. The *left* photo is the downstream side of the weir. The *right* photo is the upstream side of the weir.

One unanchored wooden weir was built to set on top of the channel and on an angle. The wooden pieces were adjusted to fit the uneven ground and banks; and in some cases, boards were trimmed to fit the angles of the ground (Figure 10). Aside from the boards, assembling the unanchored wooden weir required mainly screws. A filter fabric (using filtration geotextile) was placed on the upstream face of the wooden weirs and was fastened using metal staples. The unanchored wooden weir was installed by two people within 2 hours. A 6 in. layer of rock was piled on the upstream side of the weir to stabilize the entire system.

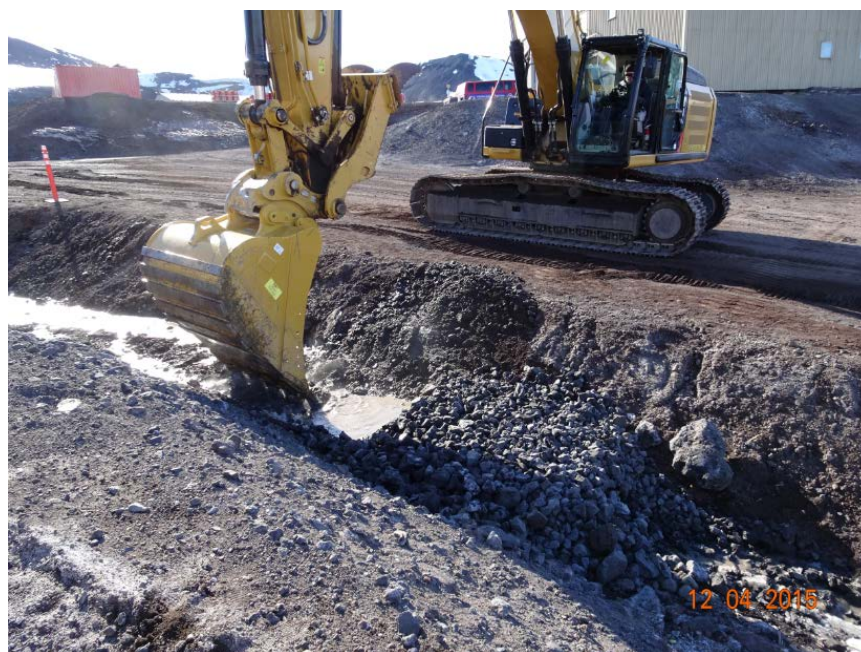
Figure 11. Rock weir using the 2 to 8 in. rocks. The excavator created a sump upstream of the weir.

It took between 3 and 4 hours to build all six rock weirs by using an excavator and a loader at the same time. The loader hauled the rocks and dumped the rocks in the selected location in the channels. The channels were previously shaped and cleared of snow and ice early in the season. The weirs used two rock size ranges: 2 to 8 in. rocks (Figure 11) and 8 to 12 in. rocks (Figure 12). Rock weirs using the 2 to 8 in. rocks were constructed along the channel near Building 175 and upstream along Gasoline Alley (Figure 11). The amount of rocks used depended on the width of the channel and the height of the weir. In upstream channels, rock weirs were built using 8 to 12 in. rocks (Figure 12). The height of the rock weirs (i.e., the height from the middle bottom of the channel to the top of the weir) depended on the channel cross section and ranged from 1.5 to 3 ft. A minimum height of 1.5 ft was used for shallow and wide channel. For narrow channels, a 3 ft rock weir height was used. The excavator was used to shape the weir, to compact the rocks, and to create a sump or depression upstream of the weirs.

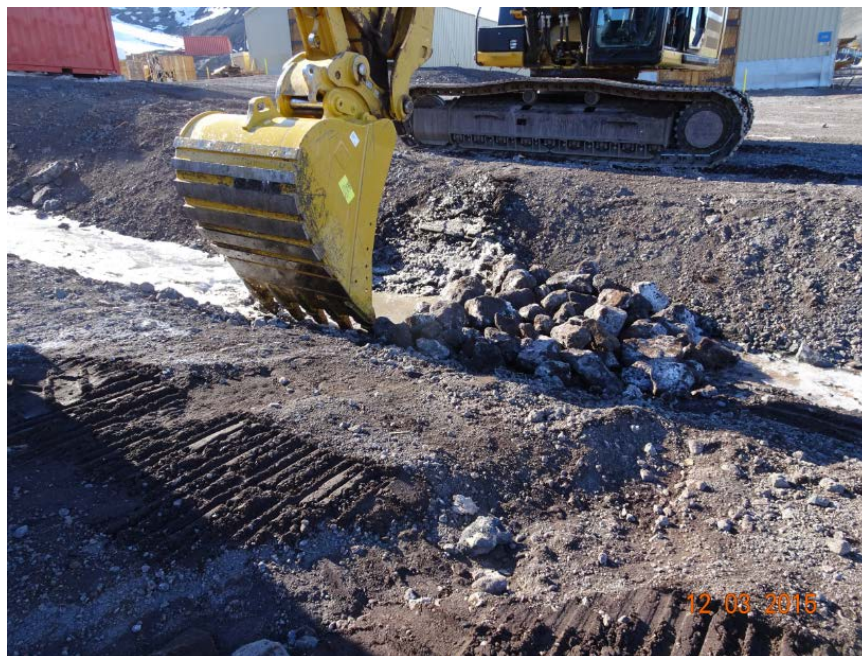
Figure 12. Rock weir using 8 to 12 in. rock sizes with a sump upstream of the weir.

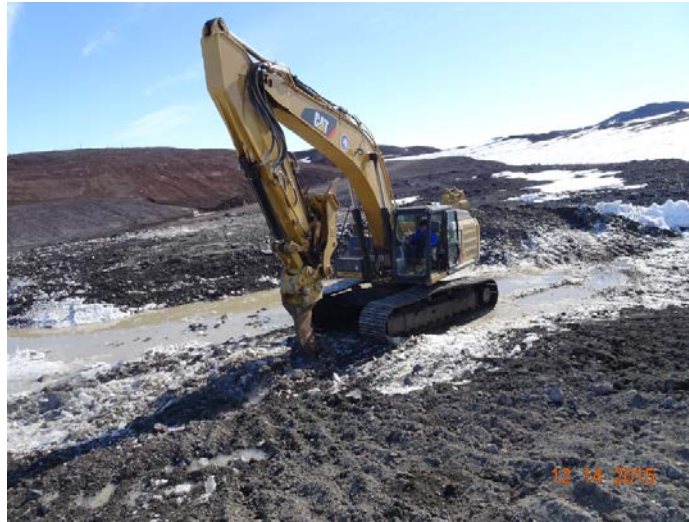
Figure 13. Digging the primary pond at Pond 3C.

An initial survey assessed the topography to determine the best location for Pond 3C. Based on the actual topography, the logical approach was to build adjoining ponds (primary and secondary ponds, Figures 13 and 14). These ponds were built as reservoirs or snowmelt settling ponds. The primary pond is located on a natural depression area. The excavator (with a bucket for digging materials and ripper and hammer, also called a hydraulic hammer or pecker, attachments for breaking the hard layer) was used for digging the pond. Building this pond included digging out a portion of the natural depression (Figure 13). Digging commenced on 12 December 2015 and continued for several days, encountering alternating layers of fractured basaltic boulders and gravelly sand deposits over massive ice layers. The fractured basaltic boulders and gravelly sand materials extracted in the pond area were placed and compacted to build up the top berm. Some boulders and rocks were set aside for building a French drain type of dike in the outlet. Downstream, the outlet is the secondary pond (Figure 14). The secondary settling pond was built to buffer the excess snowmelt from the upper pond. Constructing both the primary and secondary ponds for Pond 3C took 46 equipment hours, including final adjustments (Figure 15).

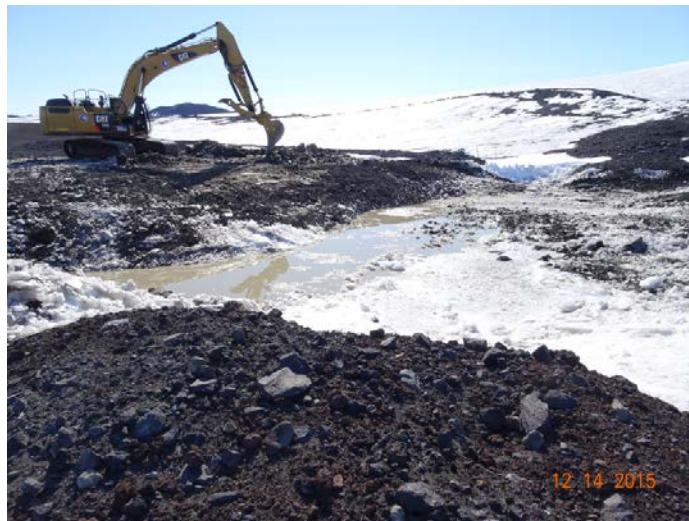
Figure 14. Digging the secondary pond.

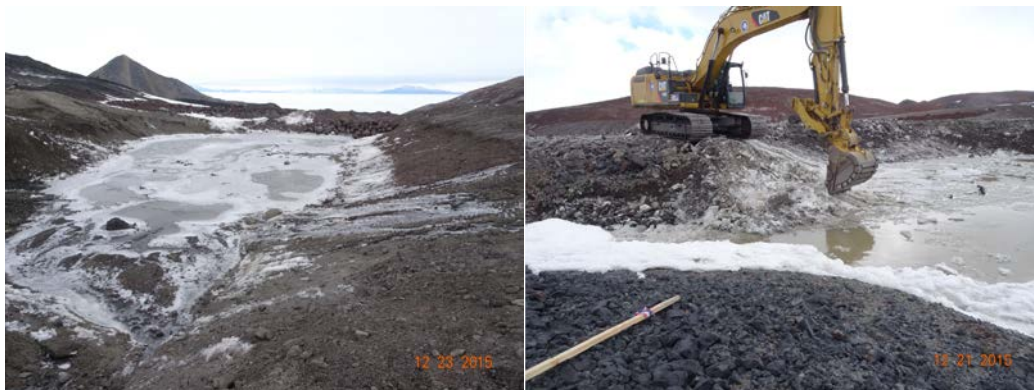
Figure 15. Fine-tuning the ponds. The *left* photo is secondary pond, and the *right* photo is the primary pond.

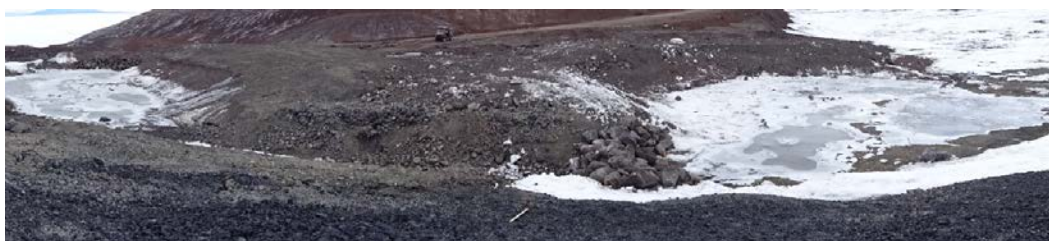
Figure 16. Perspective view of Pond 3C showing the final layout of the primary pond (*right*) and the secondary pond (*left*).

Figures 16 and 17 show the final layout of the ponds. A final survey after fine-tuning the ponds collected information about the final layout to determine the elevations, areas, and volumes. Table 3 summarizes the final sizes of the ponds, which were relatively shallow. The primary pond had a total volume of approximately 21,000 cu ft. The secondary pond covered half the size of the primary pond with a total volume of 11,000 cu ft. The total capacity was approximately 32,000 cu ft, which was significantly smaller than the minimum design for Pond 3C by a factor 15. The rationale for the limitations included that (1) the area had insufficient space to build the designed size; (2) the equipment had other projects to support and so had limited availability for this project; (3) and it was treacherous to dig deeper in ice and hard rock on unstable ground, creating safety concerns for the equipment (sliding and traction) and operator. The ponds built for Pond 3C will serve as experimental settling basins to determine whether the ponds will retain the snowmelt and whether the berm and spillway will hold up and attenuate the flow.

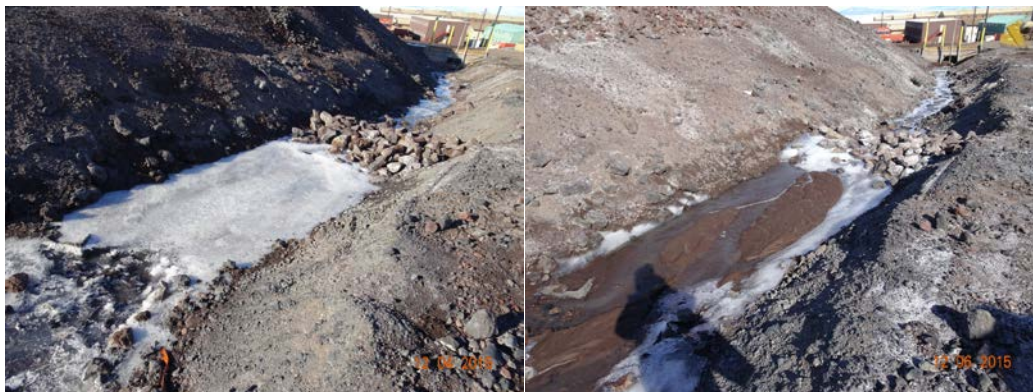
Figure 18. Water stage and sediments upstream of the rock weirs during light flow.

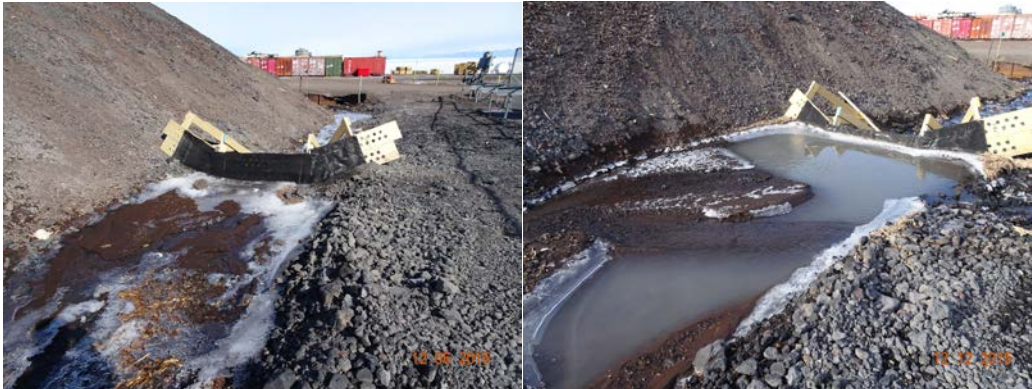
Figure 19. Water stage and sediments upstream of the unanchored wooden weir.

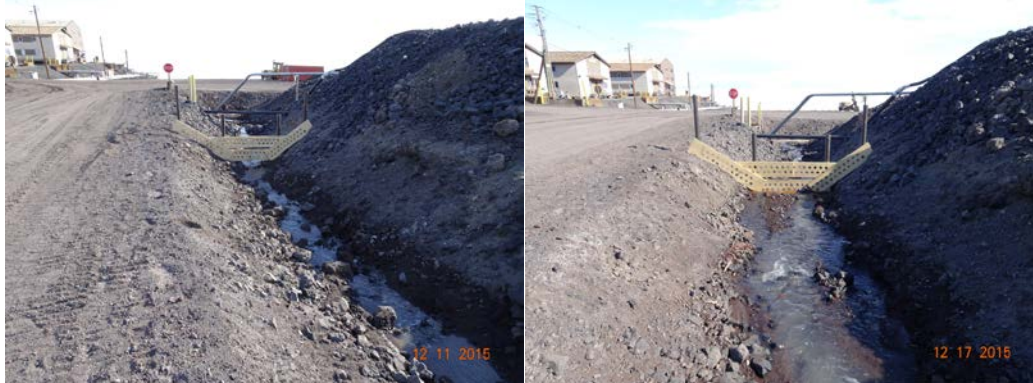
Figure 20. Water stage and sediments upstream of the anchored wooden weir.

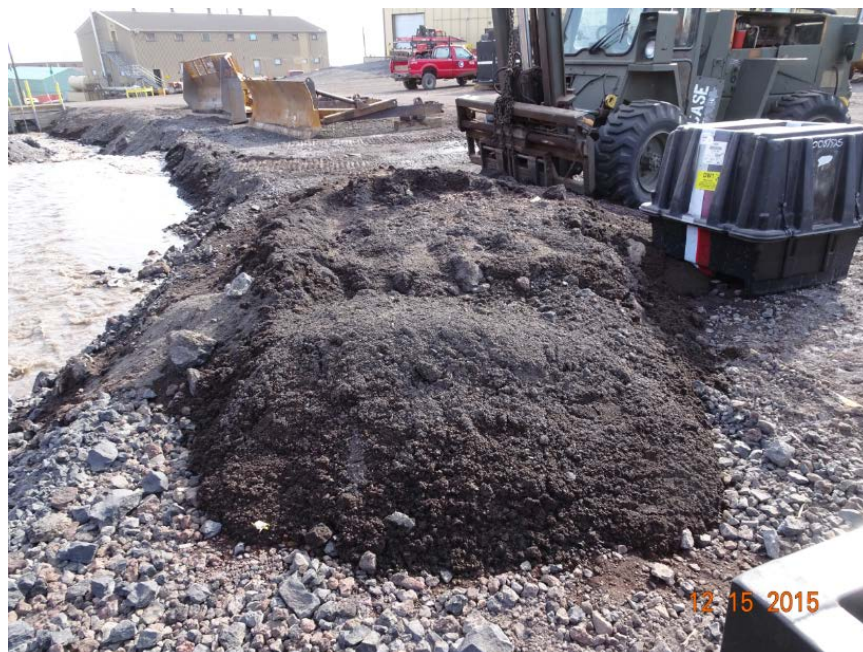
Figure 21. Typical amount of sediments collected from the weirs.

Trapped sediments upstream of the weirs were regularly scooped out with the excavator (Figure 21) and spread on the top side of the banks. Most of the runoff on the drainage channels from the first week of December 2015 to mid-December 2015 came primarily from subbasin 3. Thus, the drainage channels for subbasin 3 runoff flowed continuously at a moderate rate. Runoff from subbasin 2 that flowed in the drainage channel along Gasoline Alley was relatively light from the first week of December 2015 to mid-December 2015 (Figure 20). At that time, the snowmelt for subbasin 2 was accumulating in the existing natural depression/lake at the lower ice field.

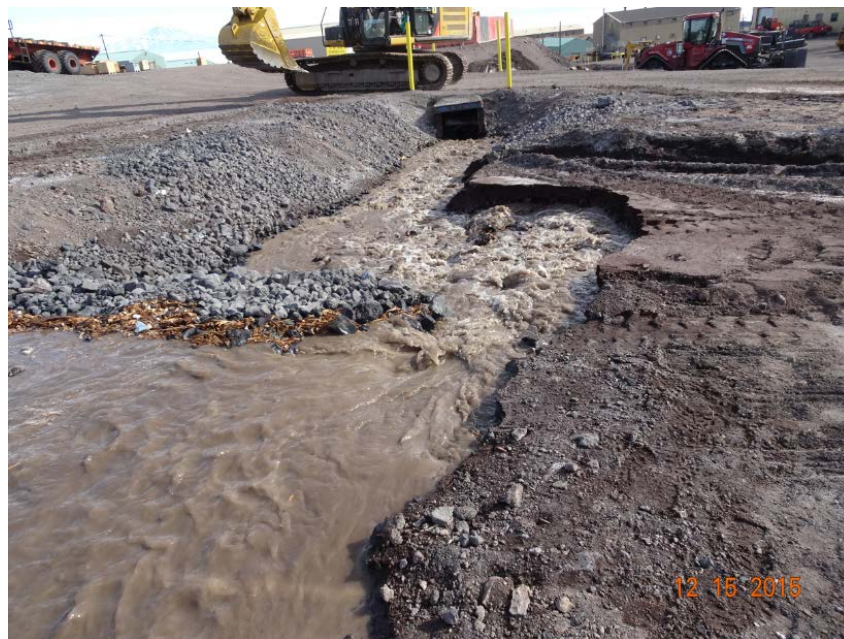
Figure 22. Example of a collapsed bank adjacent to the weir when excessive amounts of runoff occurred.

During peak and heavy runoff periods, failure in the form of erosion occurred along the bank edges next to the weirs, the massive water force eroding the material on the unprotected banks. Another reason for this failure was that the ice in the banks melted, creating space for water to flow. Bank instability was a common occurrence when excessive amounts of runoff passed through the weirs; especially banks with no stone lining or riprap were unprotected and vulnerable to failure (Figure 22).

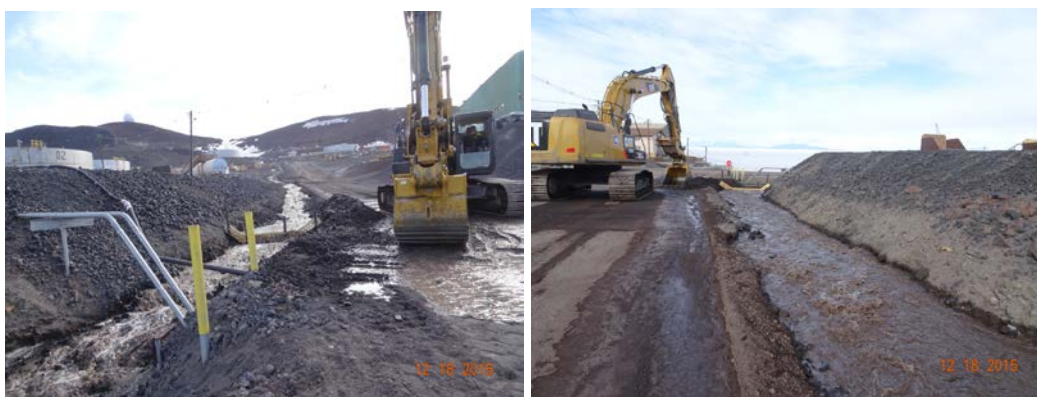
Figure 23. Extreme runoff around 9 a.m. in the drainage channel along Gasoline Alley. The *left* image shows downstream, and the *right* image shows upstream of the weir.

The anchored wooden weirs held up during an excessive runoff period. There was a surge of runoff from subbasin 2 on 18 December 2015, and it overwhelmed the drainage channel along Gasoline Alley (Figure 23). The rock pile shown on the side of the road in Figure 23 was the sediment excavated from the channel upstream of the wooden weir, and the sediments kept building up at this level of flow. By midday, the water had flowed over the weir; and a significant amount of rocks and sediments were trapped in front of it (Figure 24). At this point, the heavy-equipment operators were building a temporary berm by piling stones and rocks along the road to make sure the water stayed in the drainage channel. The excavator continued to remove the stones and rocks trapped in the weirs and deepened the channel.

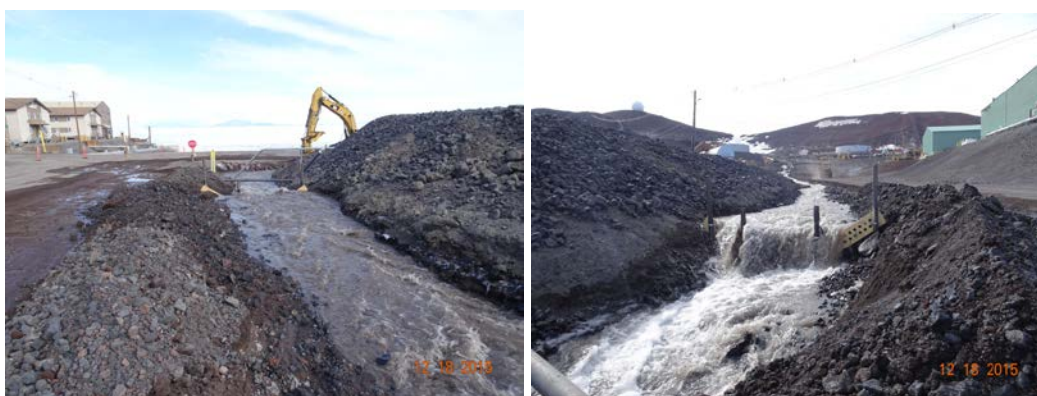
Figure 24. Extreme runoff around 3 p.m. in the drainage channel along Gasoline Alley. The *left* image shows upstream, and the *right* image shows downstream of the weir.

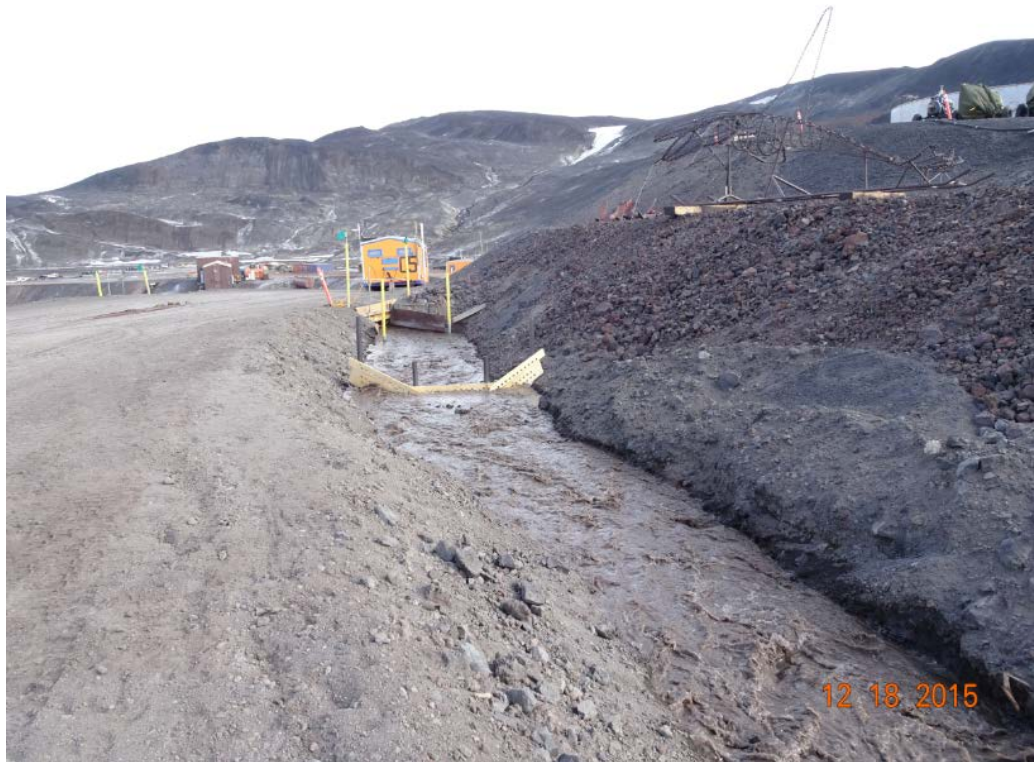
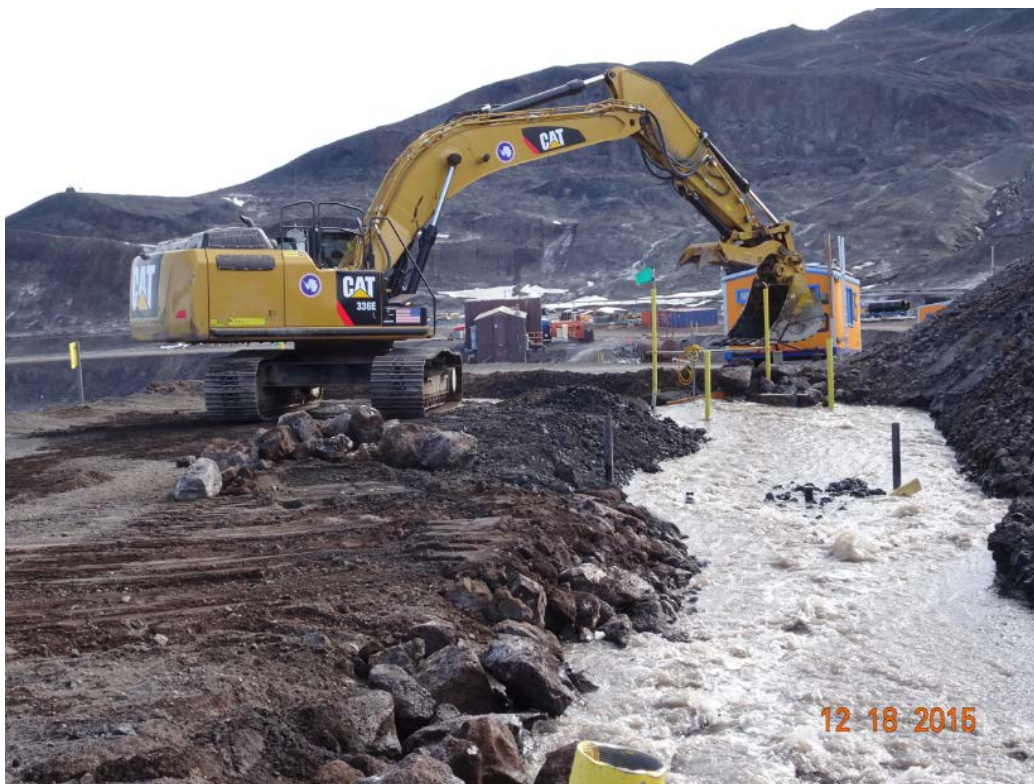
Figure 25. Runoff in the Main Road channel (the *top* picture was taken around 9 a.m., and the *bottom* picture taken around 3 p.m.).

The runoff from subbasin 3 and subbasin 2 (the flow discharged along Gasoline Alley) merged into the main channel along the Main Road, exceeding its capacity (Figure 25). With this extreme level of runoff, the wooden weir was buried in water, sandwiched between sediments and rocks, and considered nonfunctional. The excavator continued placing big rocks along vulnerable banks to minimize significant erosion and scooping sediments out of the channel. The main culvert was full with water and potentially blocked with debris and rocks; the road was purposely dug out, opening a diversion route for excess water. (There was an outburst of so much water that it looked like rapids). The excessive runoff period continued into the following day (19 December 2015) and gradually dwindled within a couple of days.
